**A Haulout**

**Gone Bad**

OUR LOSS MAY BE YOUR GAIN

## Story And Photography By DON PERRINE

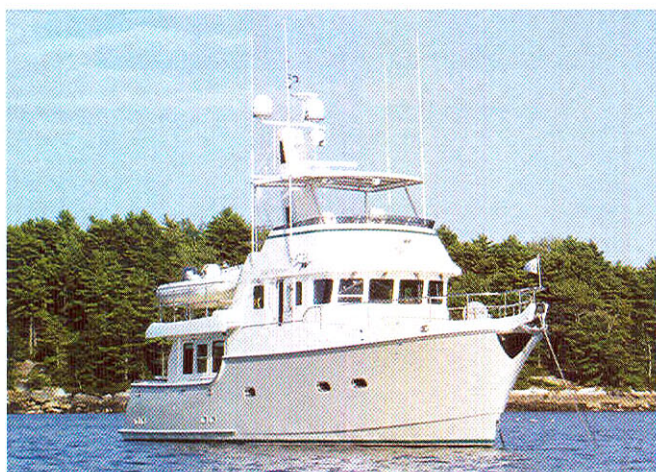
Top: Our Nordhavn before the accident. Middle: Peake Yacht Services' 150-ton Marine Travelift. Above: Centered in the lift and lines secured around her, our boat is ready for haulout.

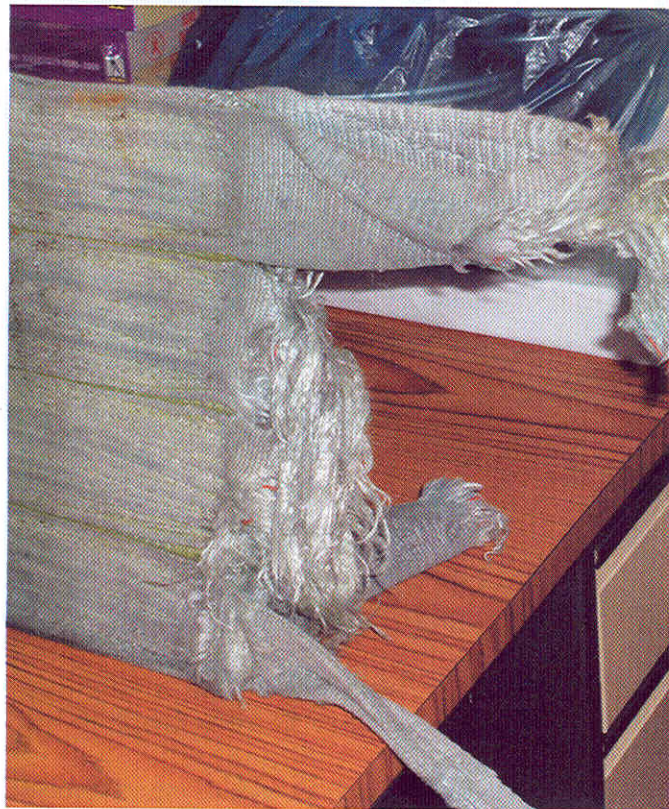
Left: The Marine Travelift pinned-type sling that failed. Right: Cracks in the lift's right tire indicate poor maintenance.

Our surveyor, Peter Gruny, also conducted an investigation into the cause of the sling failure during our haulout. According to Gruny, Peake Yacht Services did not have any of the following:

- A documented policy or procedures in place for hauling out vessels;
- A procedure in place for the periodic inspection and documentation of the condition of the slings;
- An official record/log of lift operations maintained by the lift operators;
- A policy in place for the periodic testing and certification of the slings;
- A policy in place for the handling and maintenance of the slings.

In a phone interview after the accident, Peter Peake disputed the validity of Gruny's findings. Peake said he fully attributed the accident to the lift operator's failure to use enough slings to safely lift the boat.

"The slings were not the problem. It was 'pilot error,'" Peake said. "There were not enough slings used. The operator was not thinking balance, that one sling might take more of the load than the other."

Peake said that his boatyard thoroughly inspects all slings and looks for "red guard" yarn on them. (The slings have red yarn sewn into them in such a way that it becomes visible only when a sling is wearing out and needs to be replaced.) To me, the failure of the aft sling suggests that had the policy and procedure deficiencies alleged by our surveyor been rectified by Peake Yacht Services before our haulout, we'd be happily cruising our Nordhavn to Alaska today.

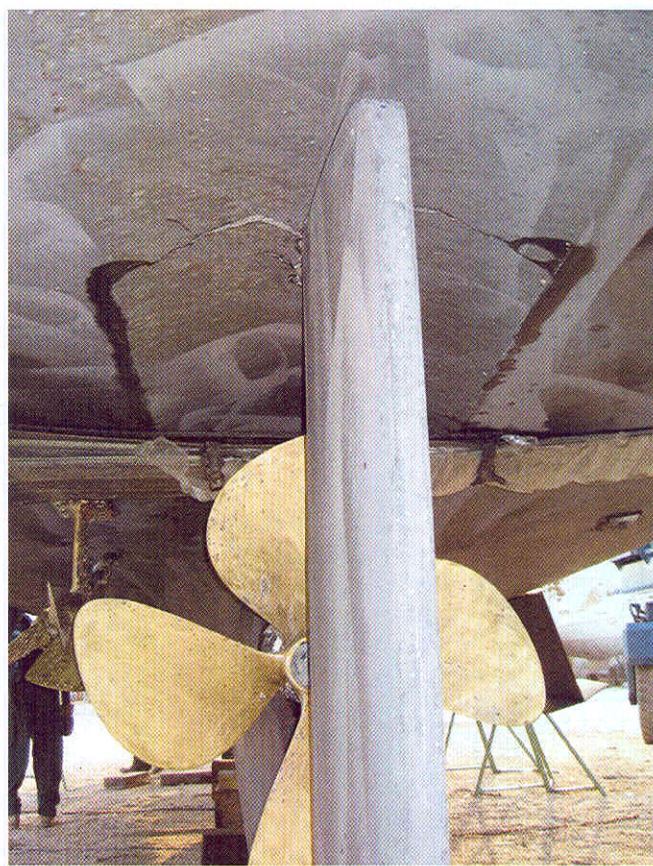
When the rudder shoe hit the concrete, the force pushed the rudder straight through the hull.

Our boat had struck the concrete with a force calculated at 480,000 lb. The rudder shoe had hit first, driving the rudder itself up into the hull approximately 8 inches. Then, the aft section of the keel had made contact with the ground and had been forced up, breaking open a section of the hull above the aft keel to the hull joint.

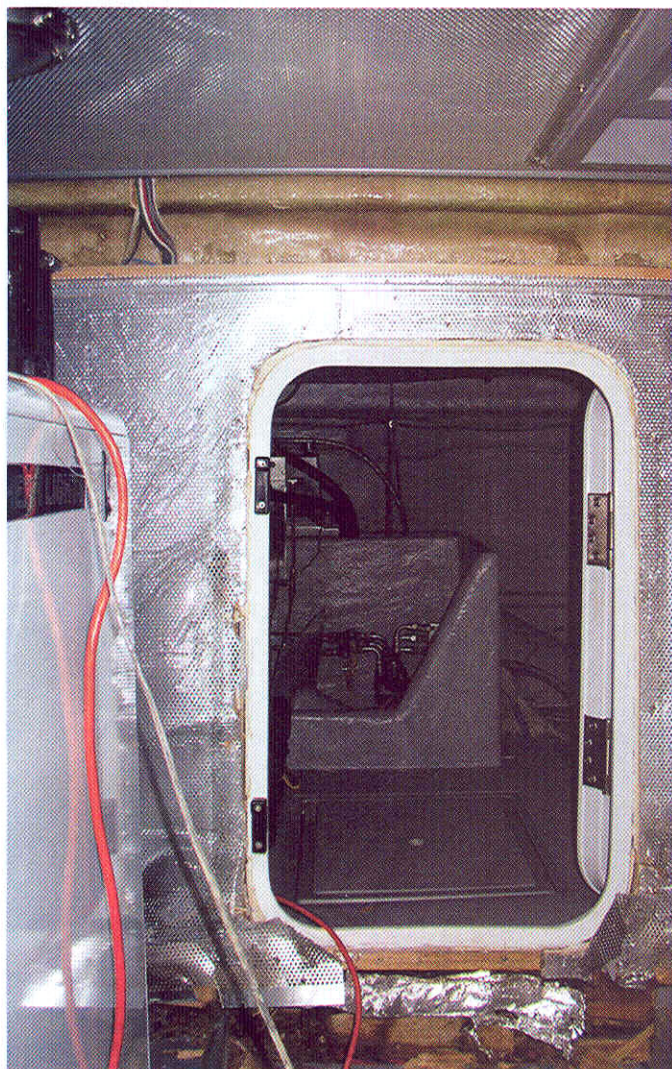
Left: In addition to other damage, the aft engine room bulkhead was crushed and the sheeting was crumpled by the drop. Right: This strainer was pushed askew when the bulkhead was damaged.
